3 Court Street

Project Details

Phase 2: Remedial works funded by an SESF Grant - Big Issue Invest

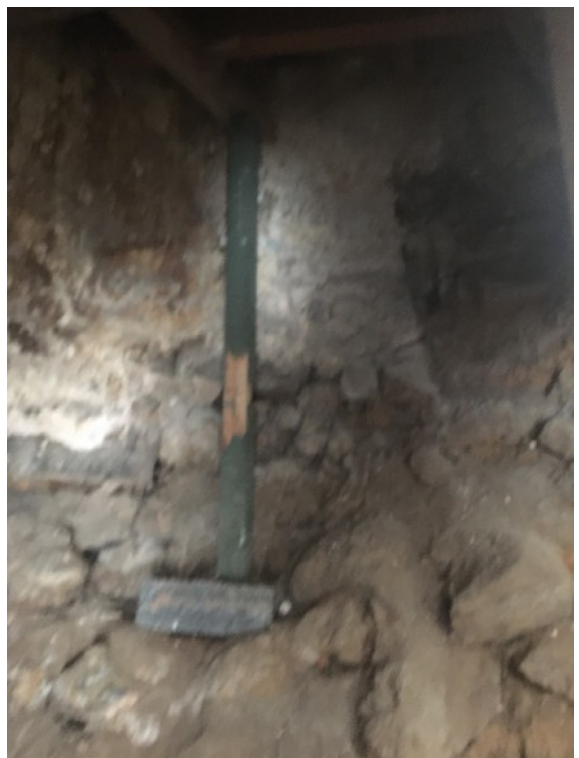
The arrow points to the 3x1inch rotten timber which is the only thing holding up the smoke blackened A frame above.

When we started removing the old dentist surgery and peeling back the years of abuse and neglect we found horrors such as the smoke blackened roof beams sitting on a woodworm riddled and rotten piece of 3.1 timber... that A Frame was holding up the whole roof! Not to mention that one of the beams holding up the entire chimney had been sawn through at sometime in the past, or that the front wall was so thin and fragile that it could have fallen out into the road, or that the dentist chair had been sitting on rotten floorboards and floor joists and could have fallen through the floor at any time, or that the 'fire wall' (and we use this term very loosely) to next door was made up of bits of board nailed haphazardly onto timbers with massive gaps...

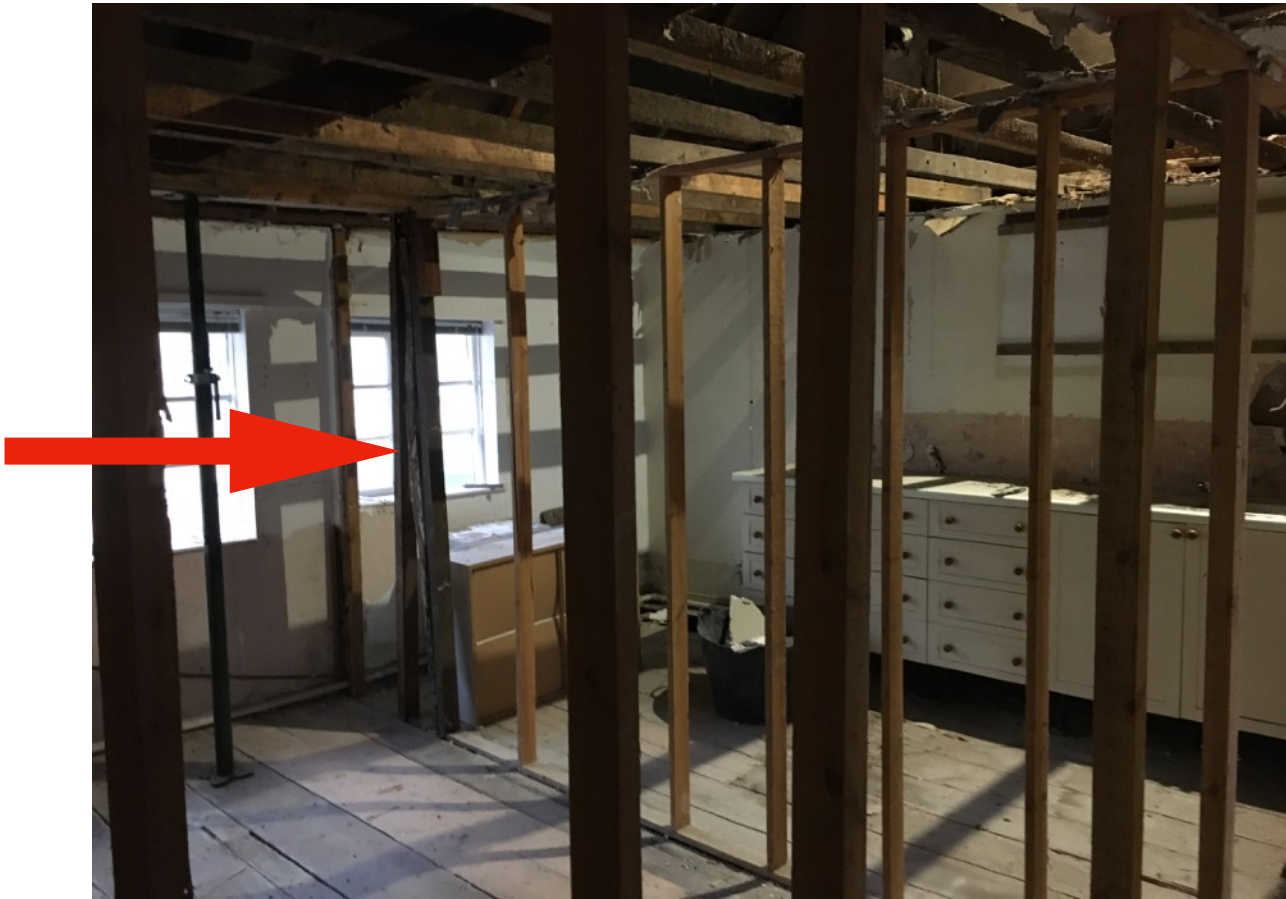
Exposing the old chimney and oak lintel. That white thing is the fixings for the dentist light that hung over the chair.

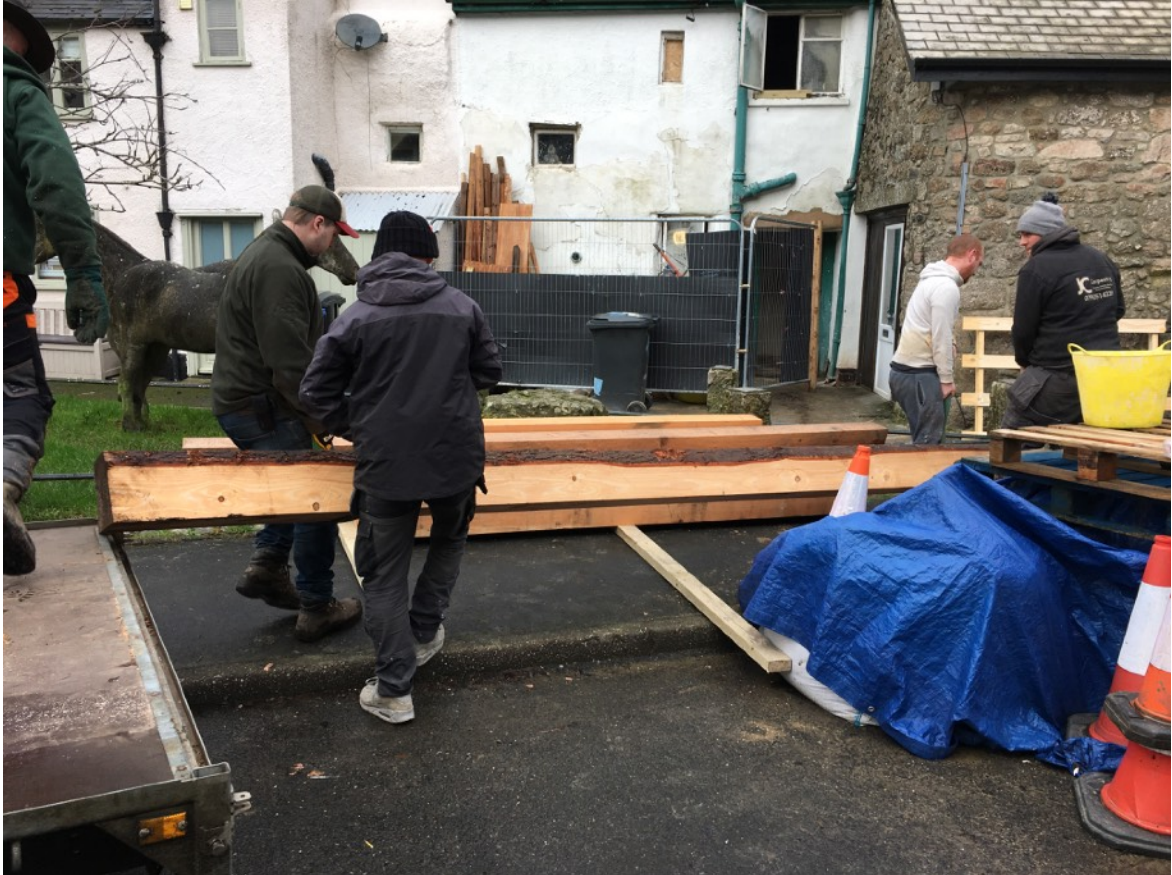
It took a lot of sweat and tears, some very strong men and a whole load of determination to manoeuvre this huge timber into place.

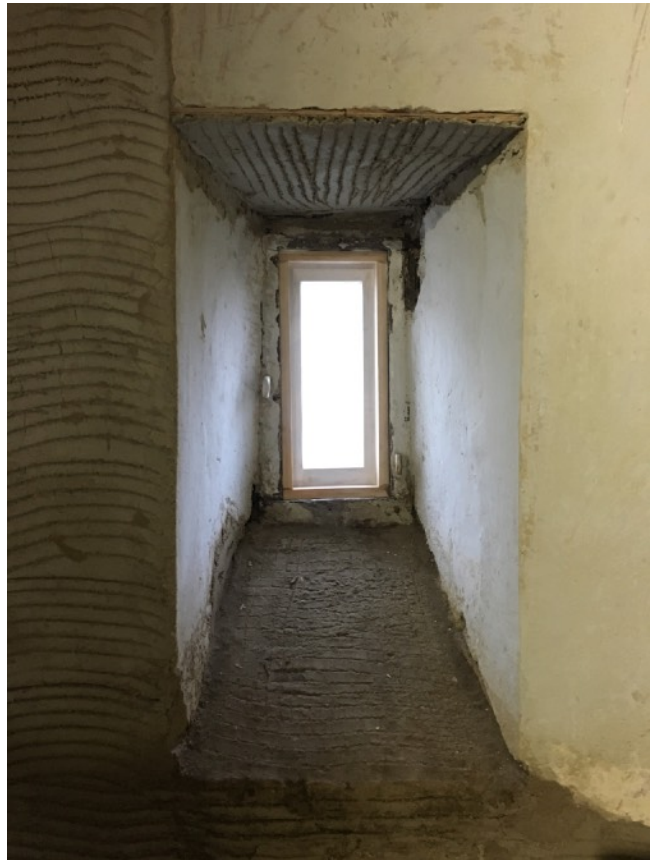
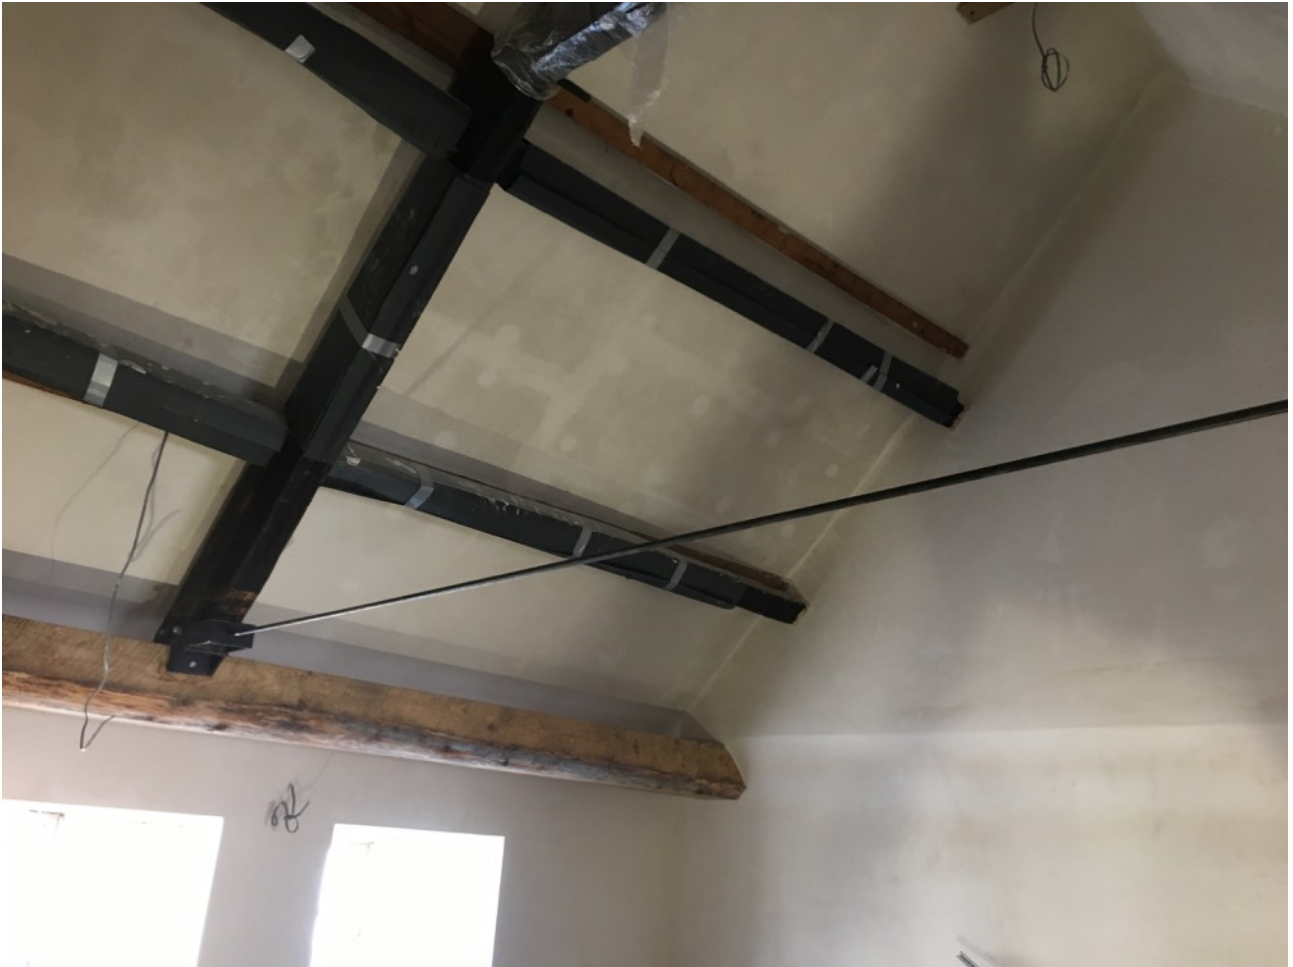
The metalwork is in to keep the A frame rigid, made by a local blacksmith.

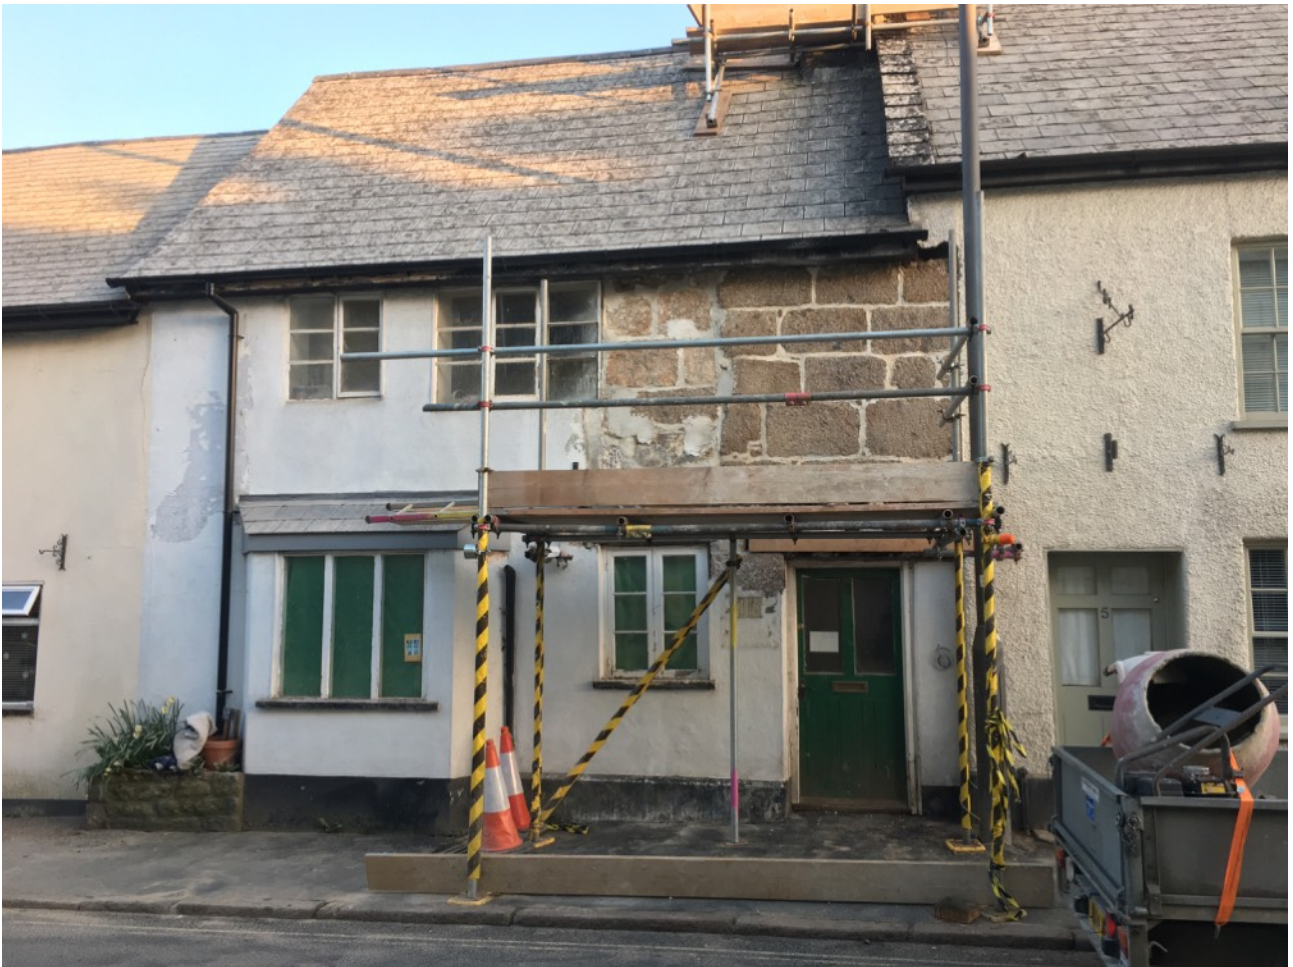
Then the back wall fell off...

The rear wall has to take priority with a new structural lintel required above the door and the window, deep pointing, then pointing on top of pointing and rendering, and so on.

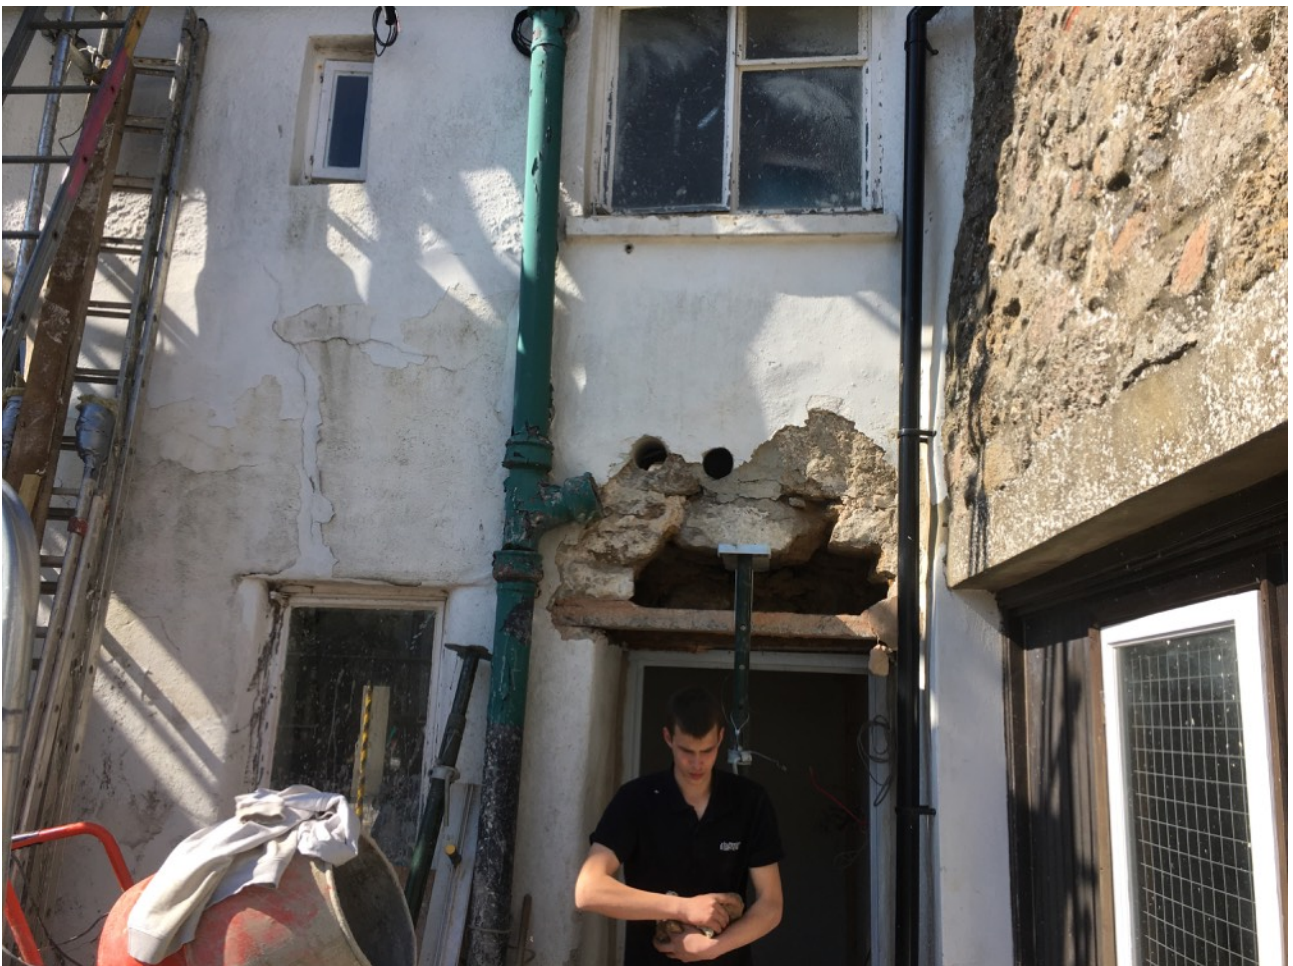
... revealing the Oak lintel that was holding up the wall to the rear of the property,,,

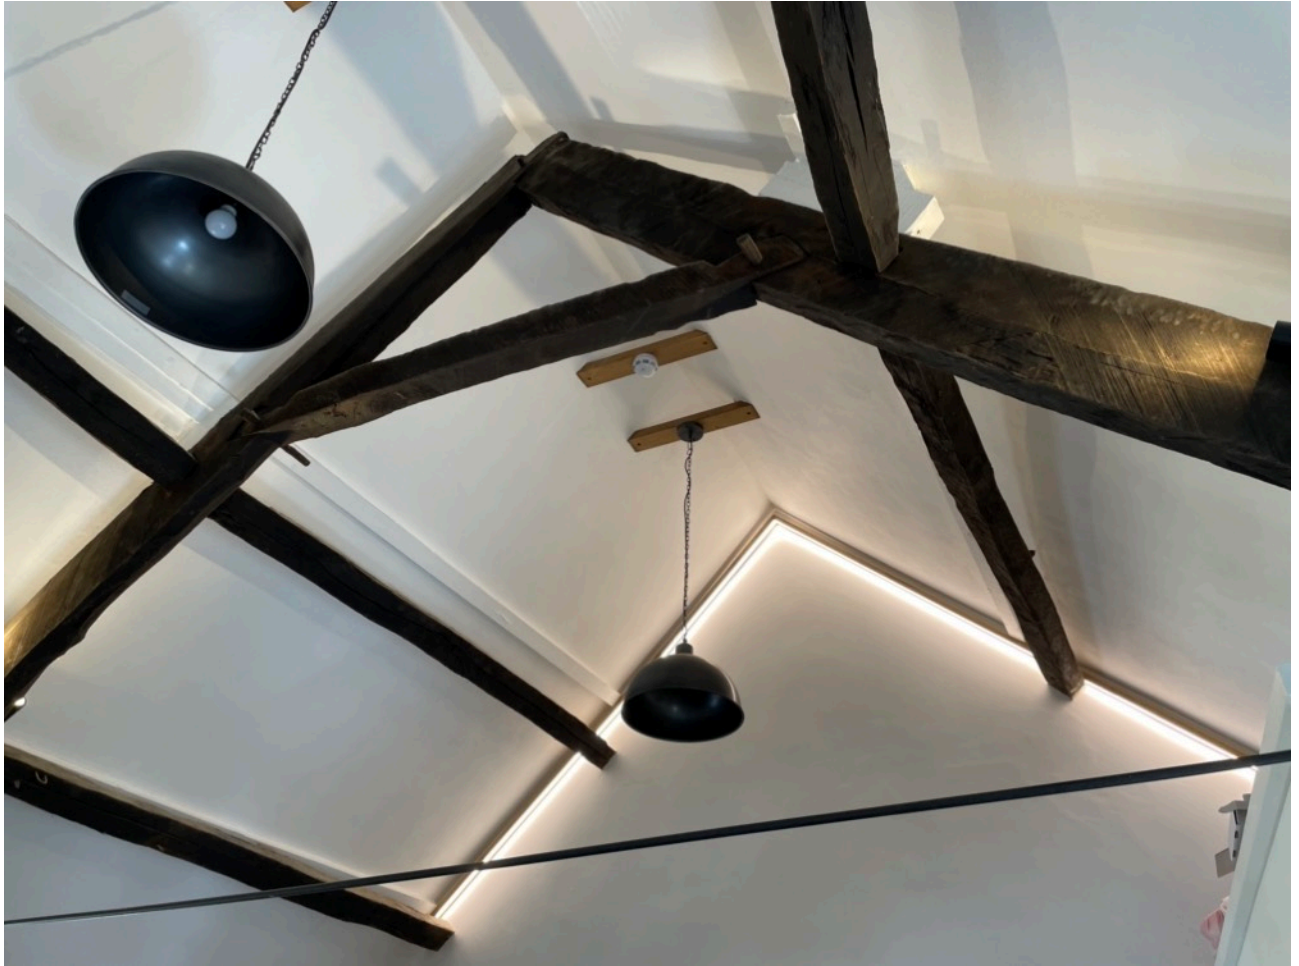
The Small window at the top of the stairs with exposed original lintel.

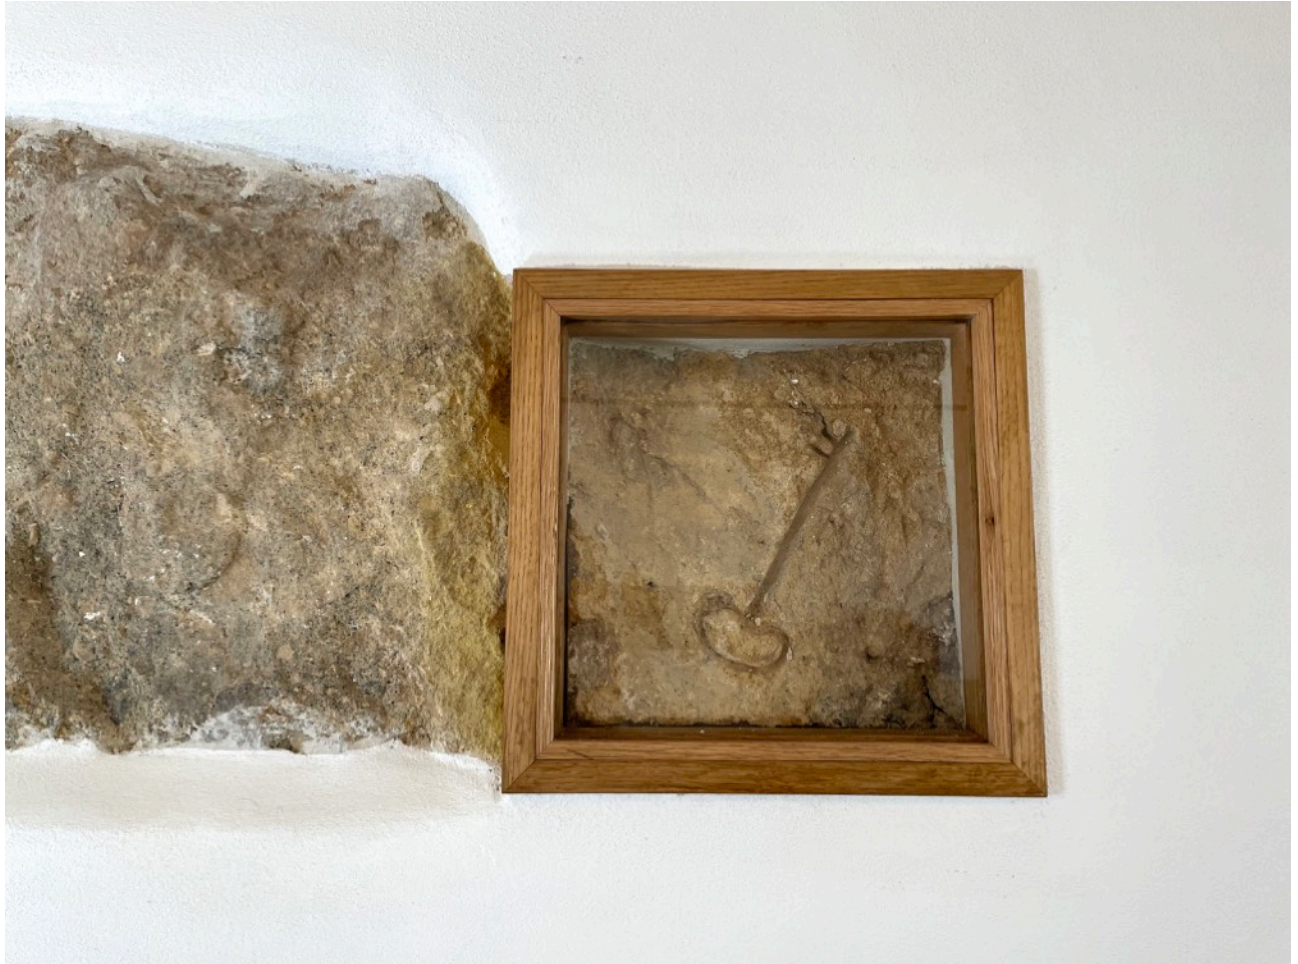
The front of 3 Court Street with the exposed granite faced stones.

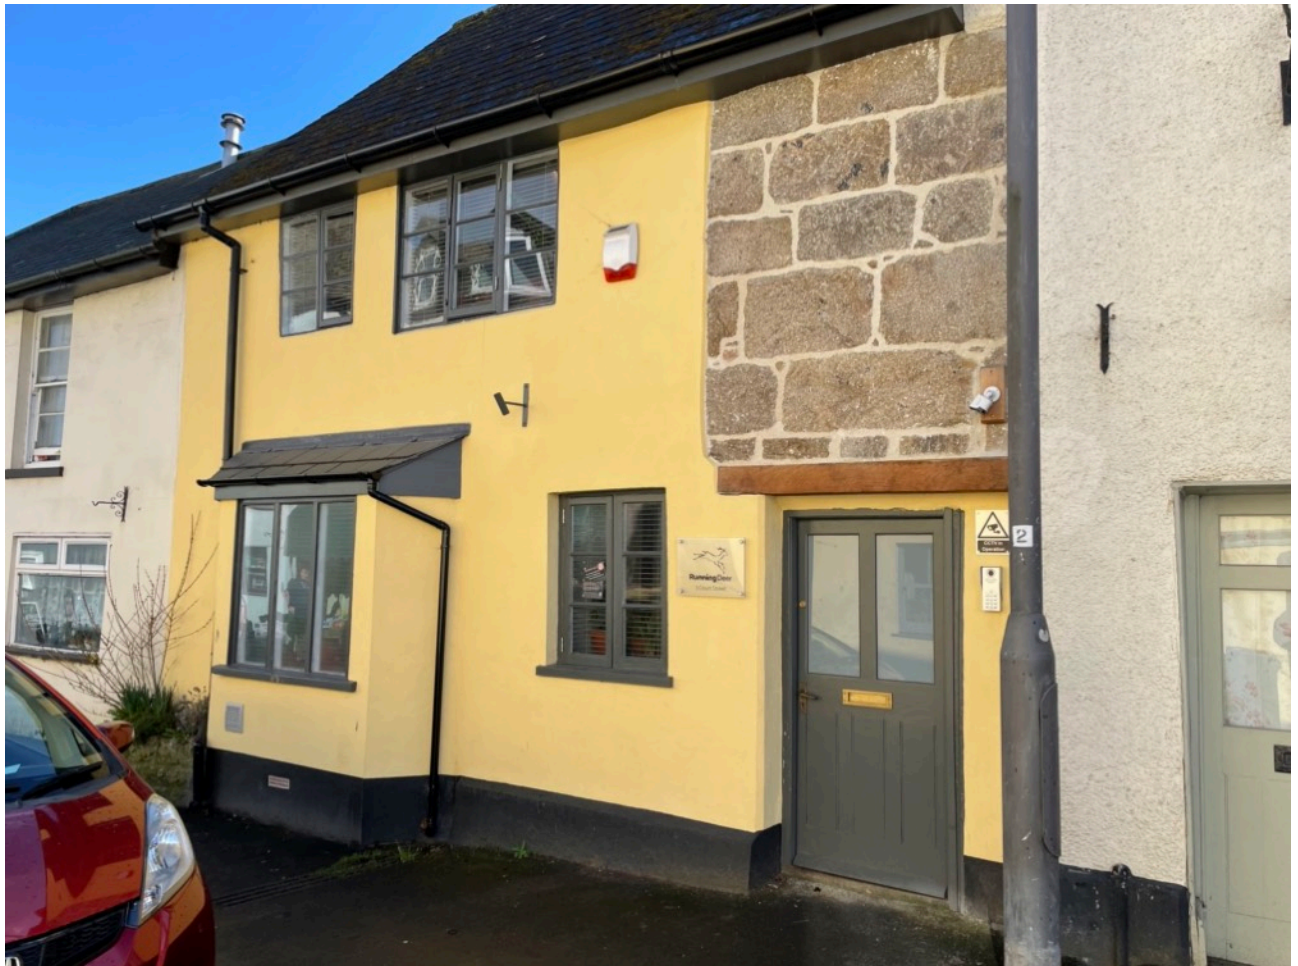
Rear of 3 Court Street, the lintel over door replaced with oak beam, guttering replaced.
